Architectural Uses Of Copper

An evaluation of stormwater pollution loads and best management practices

Palo Alto Regional Water Quality Control Plant

November 2000 Revision 2 • March 2001

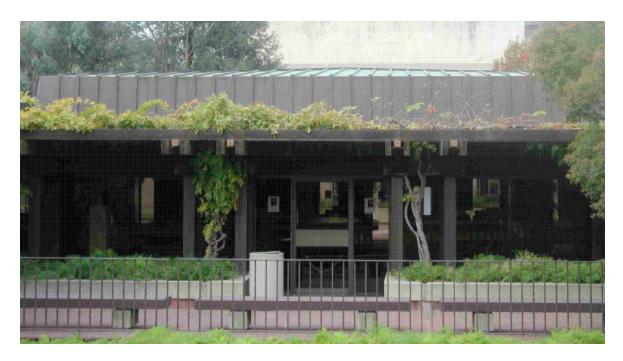
Photo: Copper Roof (Hoover Center, Stanford University)

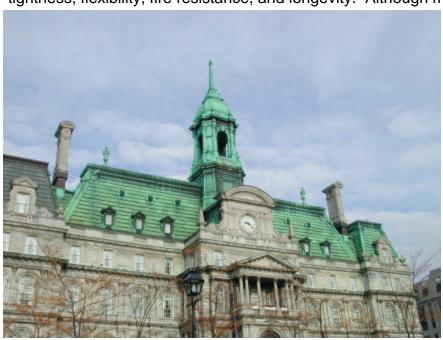
Copper roofs and flashing are fabricated into standard or custom shapes by a number of manufacturers. Roof panels (see photo at left) are commonly from 0.4 to 1.0 m (16 to 36 in) wide, and up to 3.1 m (10 ft) long, with other sizes available via special order.

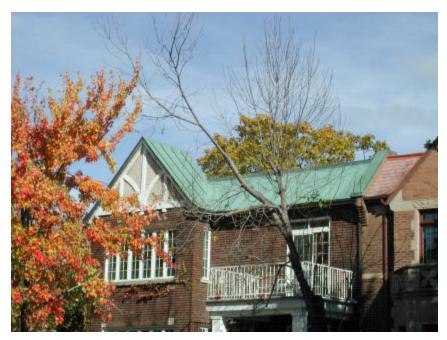
Copper roof and flashing pieces come with either a bare metal finish, or with a factory-applied weathered appearance (i.e., a "patina"). Copper pieces of either type are special order items that are not stocked in local building supply stores.

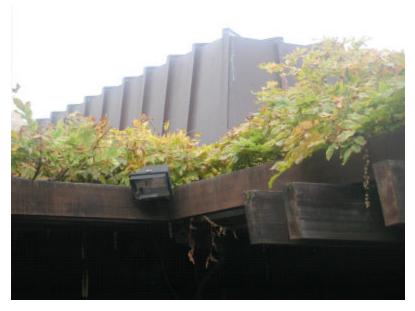
available to accelerate the aging of bare copper so that a light-green patina finish develops more quickly than the 7 to 10 years required for normal weathering. Suppliers indicate that these field-applied solutions require great skill to handle correctly, cost about \$5.00 per sqm (\$0.50 per sqft), and are most often used for small copper features rather than entire roofs. Use of such chemicals has a relatively high risk of soil or groundwater contamination during construction. [3, 4]

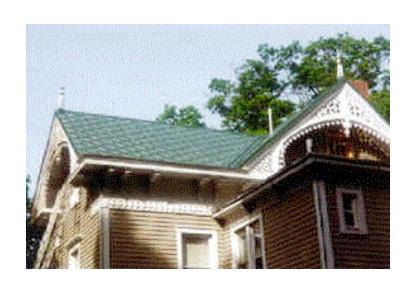
Coated steel roofing sheets, shingles (photo), and tiles are available in colors that closely match the red gold of bare copper or the light green of a copper patina. Companion features, such as gutters, downspouts, and appurtenances, are available in matching colors and textures. With proper installation, the expected life of these features should be over 100 years. [30]

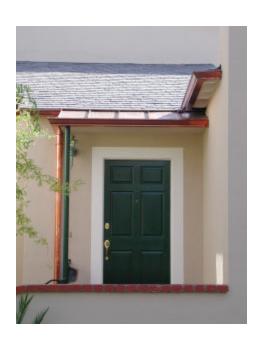
Although specific data are not available, copper drainage features (photo) are known to be used with a variety of different roofing types, and are therefore believed to be somewhat more common in the Bay Area than are complete roofs made of bare copper metal or copper-containing shingles.

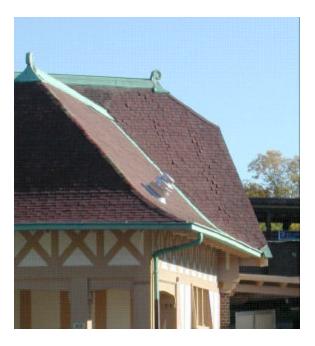
Copper is used for spires, cupolas, doors, lights, signs, railings, weather vanes and other exterior ornamental features (photo), concrete inserts, water stops, and garden edging strips. Copper releases from these small features are believed to be less significant than that from complete roofs made of copper.

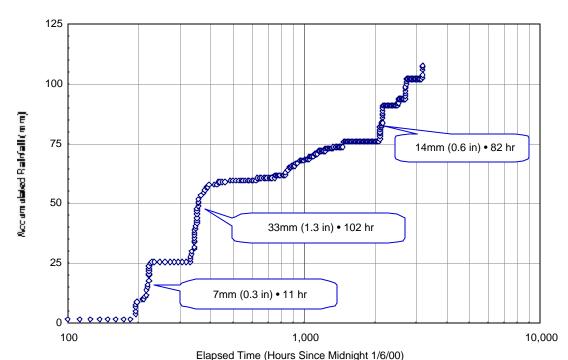
Exhibit 4
Accumulated Rainfall (1/00 - 4/00) - Palo Alto Airport

About 110 mm (4 in) of rain fell in Palo Alto during January - May 2000. Half of this amount (54 mm) occurred in three major storms that ranged in duration from 11 to 102 hours. Intensities for these highlighted storms varied from 0.17 to 0.64 mm/hr. The latter value is used later in the report to conservatively estimate the flow capacity required of alternative copper removal treatment systems. [29]

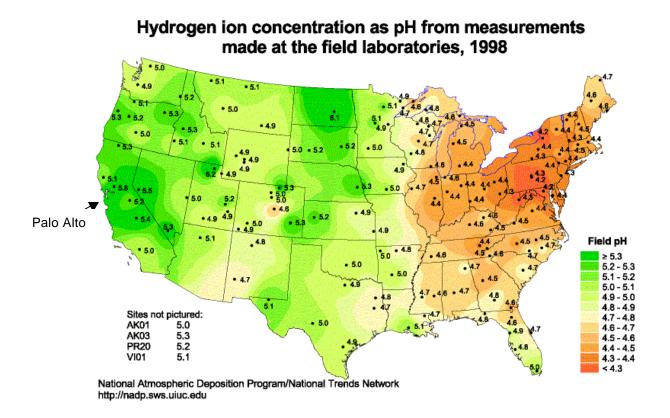
Exhibit 5

The National Atmospheric Deposition Program (NADP) maintains two field monitoring stations in California that are within about 100 km (62 mi) of Palo Alto. Exhibit 5, obtained from the indicated NADP website, shows that pH values at these stations were in the range of 5.1 to 5.8 for Calendar 1998.

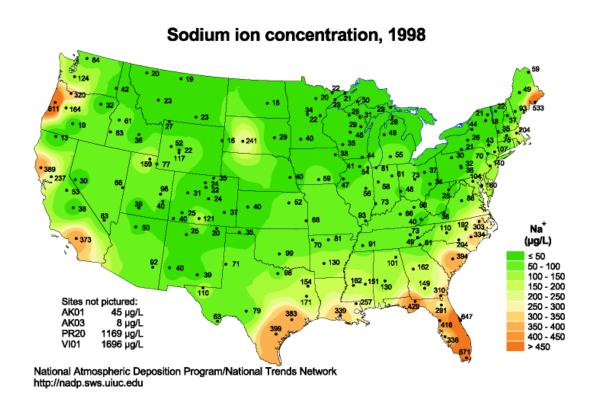
Exhibit 6

Exhibit 6, also adapted from the referenced NADP website, shows that the sodium content of local rainfall is in the range of $400 \,\mu\text{g/l}$. Exhibit 7 is a composite satellite image from the US Geological Survey which emphasizes that this salinity level results from the proximity of the Palo Alto RWQCP service area to the San Francisco Bay and the Pacific Ocean to. [38]

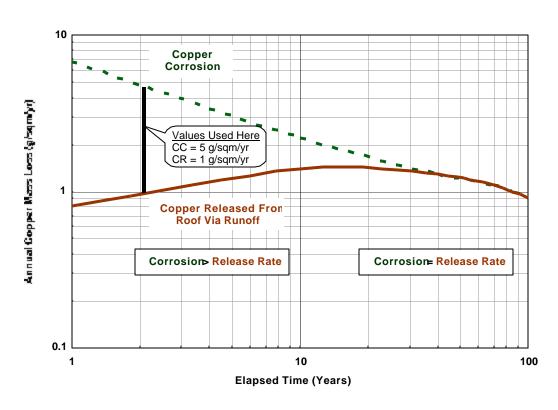
Exhibit 11 [Revision 1]
Typical Relationship Between Corrosion and Copper Removed By Runoff

This variability is illustrated by Exhibits 11 and 12. Exhibit 11 shows how the annual rate of copper corrosion decreases through time as a patina forms and begins to protect the surface. The amount of corrosion byproducts that rainfall washes from the roof is initially small, and then increases over a period of years to reach a steady state equal to the rate of corrosion. [35] Salt in the air and acidic rainfall tend to increase both the corrosion and copper release rates. [18]

Note: This chart is for illustration only. It does not portray data obtained from actual field measurements. $CC = Copper\ Corrosion$. $CR = Copper\ Release$.

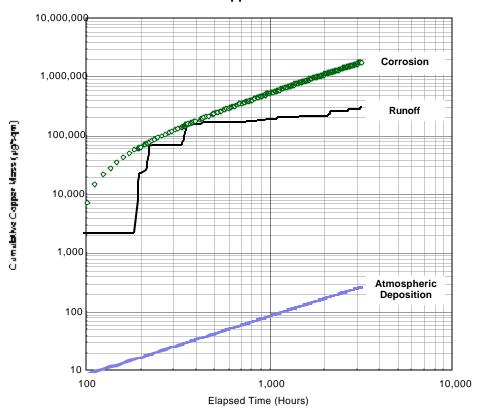
Exhibit 12
Predicted Unit Copper Mass Loss in Rainfall Runoff

Exhibit 12 shows accumulative corrosion and runoff releases predicted for a hypothetical building in Palo Alto with a newly-installed copper roof. These

Exhibit 12 also shows the key conclusion that, overall, the copper mass released from corrosion is about 1,000 times the amount of copper added to the roof via wet and dry atmospheric deposition. In addition:

- The line of diamond symbols represents cumulative corrosion of copper from an example roof, which reaches an estimated total of about 1,800,000 μg/sqm in the first 3,000 hours of the Year 2000.

- This amount is equivalent to an estimated annual corrosion rate of 5 g/sqm/yr [see Exhibit 10].
- The upper solid line represents the intermittent release of copper mass in rainfall runoff from the example roof. This copper mass totals an estimated 300,000 µg/sqm in the first 3,000 hours of the year.

- Annually the copper mass runoff rate is estimated as 1 g/sqm/yr.
- The graph shows that for the first several hundred hours almost all of the corrosion products are removed during two storm events. Thereafter, copper releases continue, but at a rate that is less than the corrosion.

- The lower line in Exhibit 12 shows that atmospheric deposition of copper totals about 300 μg/sqm in 3,000 hours.
- Annually, combined wet and dry atmospheric deposition will together add 860 µg/sqm/yr to the roof surface. [see Exhibit 8]

Note: The runoff curve matches storm events during the first 3,000 hours of the Year 2000.

This evaluation concludes that atmospheric deposition is significantly less per unit area than the amount of copper mass released by corrosion from a roof of that metal. Therefore, wet and dry deposition are neglected in the estimates that follow.

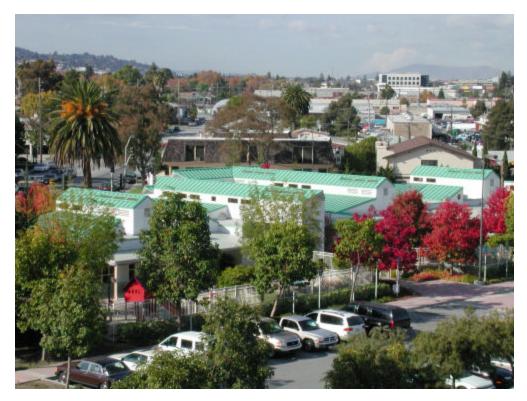
Photo: School With Coated Steel Roof

Exhibit 17 summarizes the costs associated with alternative BMPs for reducing the copper load in runoff from a 232 sqm (2,500 sqft) residence with copper gutters, downspout, and roof. The metals removal treatment system uses gravity-flow and does not require a buried cistern or pump.

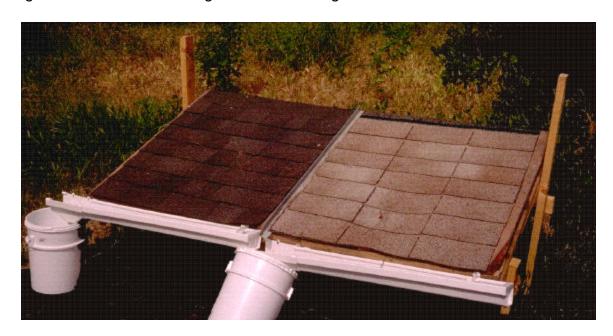
Standard and Algae-Resistant Composition Shingles

This photo shows the test stand located at the Palo Alto RWQCP that was used to measure copper in rainfall runoff. Each side of the test stand measures about 1.1 sqm. The left half of the stand is covered with standard shingles, while the right half is covered with algae-resistant shingles.
